Maintainer

Issue 2/2004

Cross-Wired Side-Stick Almost Brings Down Airbus A320

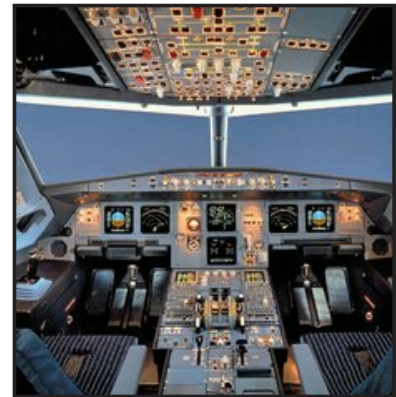
Investigation of the incident revealed that as the technicians were troubleshooting and repairing the elevator and aileron computer (ELAC) system, they found a damaged pin on one segment of the four connector segments, with 140 pins each, on the rack side of the ELAC mount. The repair work performed by various technicians over several shifts involved a complete rewiring upstream of the connector pins. During this process, the polarity was inadvertently reversed on four wires in one connector segment. Two of the wires were for the roll control input and two were for the associated channel outputs. It is believed that the technicians correctly followed the wiring list but that this list can vary by aircraft serial number. Extreme care must be taken to match up the correct wiring list by tail-number (aircraft-affectivity). Since the ELACs are interchangeable from one aircraft to the other, it is thought that the issue of crossed-wiring has at its source the colour coding scheme of the wiring on the backside of the connectors on the rack to which the ELAC is mated.

electronic centralized aircraft monitoring system (ECAM). The flight control check was limited to the F/O's side-stick. The fault got by at least two safety filters, as it was neither detected by maintenance nor at the pre-flight check.

In this instance, the captain and the F/O displayed remarkable adherence to cockpit resource management (CRM) principles and saved the day. Likewise, maintenance crews must go through the functional test procedures diligently each time that major work is performed on aircraft flight controls. The time spent double-checking each step of the procedures is well worth the effort in the recognition of a job well done on such complex and sophisticated systems. Keep up the good work! ✈️

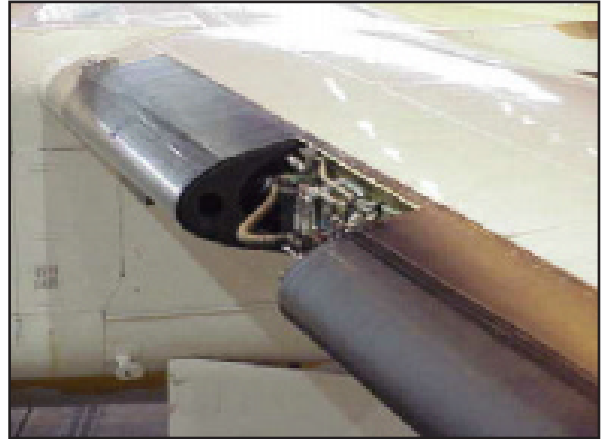
Leading edge failure in flight: cost \$50,000. Fluorescent trail marker ribbon and masking tape: cost \$0.10.

The aircraft departed on a scheduled flight and as it rotated in the take-off sequence, 38 in. of the leading edge skin and the de-icing boot assembly came off the left wing. The crew felt a

Investigation revealed that the lower attachment screws had not been installed and that inspection had failed to observe the discrepancy. If there been a procedure in which work cards were used to report that each step of the job had been completed, inspected and signed off, the risk of such an occurrence happening would have been lower. The maintenance system and maintenance personnel failed. It is hoped that this company adopts a safety management system (SMS) that includes a maintenance error management program. This should assist them in identifying all of the factors that came into play during this event and prevent them from ever happening again. We are all responsible for safety; it has to be foremost in our mind when we set out to perform maintenance on these complex aircraft and systems. Costs of unscheduled maintenance are horrific. Can we afford to go on and be part of this when all that is required is a little more care? Be part of the solution, not part of the problem. ✈️
